ANALYSIS OF DAMAGE CHARACTERISTICS OF URBAN ROAD ASPHALT PAVEMENTS USING THE BINA MARGA AND ASPHALT INSTITUTE MS-17 METHODS

(Study Case: Serang - Pandeglang Highway, Serang City - Banten)

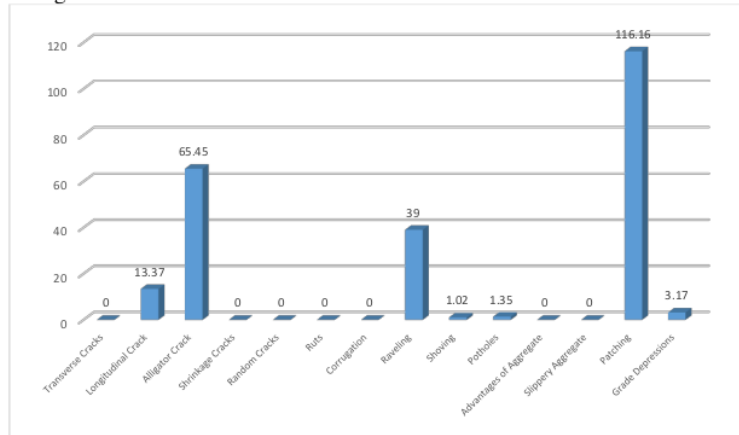
Figure 5 Diagram of the extent of damage in both methods

Damage to the Serang – Pandeglang highway, based on a road assessment survey, found 7 types of damage out of 13 types of damage in 2 (two) road damage assessment methods. The highest damage area was the patch damage type which had a total area of 116.16 m2 and the lowest was the fall damage type of 1.02 m2. In the community development method, the largest type of damage is a patch of 116.16 m2 and the smallest type of damage is a hole of 1.35 m2. In the Asphalt Institute MS-17 method, the largest type of damage is loose granules of 39.00 m2 and the smallest type of damage is falling of 1.02 m2.
