LAMPIRAN

Lampiran C Form Hasil Pengujian *Thermography Incoming UMVB (F2) Connection S-T Januari 2023*

Lampiran D Single Line Diagram (SLD) Sistem Transmisi MV Switchgear 6.3 Kv

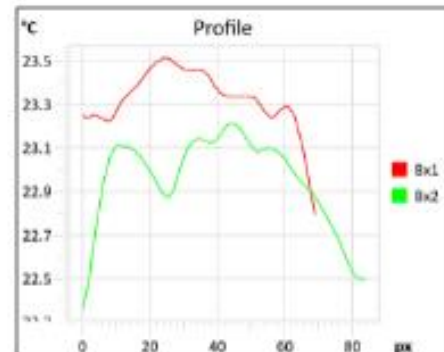
Lampiran C Form Hasil Pengujian *Thermography Incoming UMVB (F1) Connection R-S* Februari 2023

Remarks	
Location: UMVB	Power Plant Incoming UMVB (F1) Connection R-S

Measurements	
Bx1	
Max	23.9 °C
Bx2	
Max	23.5 °C
Dt1	
Bx1.Max-Bx2.Max	0.4 °C

Grade Level **C**

Normal Condition

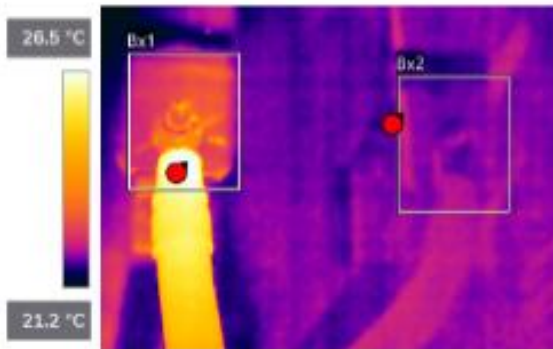
Lampiran C Form Hasil Pengujian *Thermography* UMVB CT E (F14) *Connection R-S* Februari 2023

Remarks	
Location: UMVB	Power Plant UMVB CT E (F14) connection R-S

Measurements	
Bx1	
Max	26.7 °C
Bx2	
Max	22.3 °C
Dt1	
Bx1.Max-Bx2.Max	4.4 °C

Grade Level **0**

Normal Condition

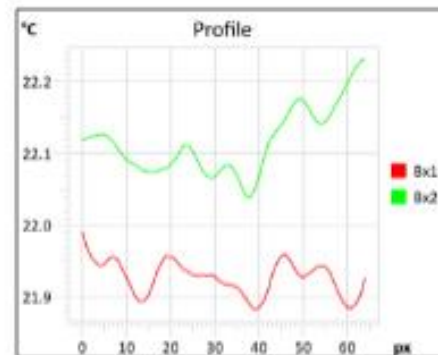
Lampiran C Form Hasil Pengujian *Thermography* UMVB Raw Water (F18) Connection R-S Februari 2023

Remarks	
Location	Power Plant
UMVB	UMVB Raw Water (F18) connection R-S

Measurements	
Bx1	
Max	22.1 °C
Bx2	
Max	22.3 °C
Dt1	
Bx2.Max-Bx1.Max	0.2 °C

Grade Level **0**

Normal Condition

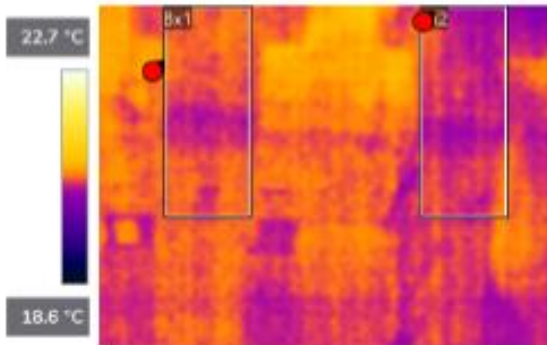
Lampiran C Form Hasil Pengujian *Thermography* UMVB Steamfield (F19) Connection R-S Februari 2023

Remarks	
Location	Power Plant
UMVB	UMVB Steamfield (F19) connection R-S

Measurements	
Bx1	
Max	20.9 °C
Bx2	
Max	20.8 °C
Dt1	
Bx1.Max-Bx2.Max	0.1 °C

Grade Level **0**

Normal Condition

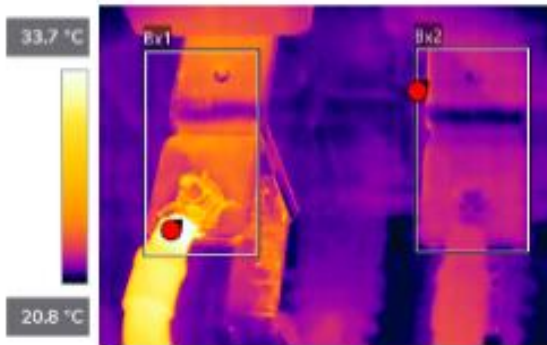
Lampiran E Hasil Pengujian *Thermography* UMVB HWP A (F8) Maret Minggu ke-1 Phase S-T

Remarks	
Location	Power Plant
UMVB	UMVB HWP A (F8) Connection S-T

Measurements	
Bx1	
Max	33.3 °C
Bx2	
Max	24.1 °C
Dt1	
Bx1.Max-Bx2.Max	11.2 °C

Grade Level Grade 1

Monitor Condition
